Fukushima and its consequences

Jim Thomson

29th November 2011

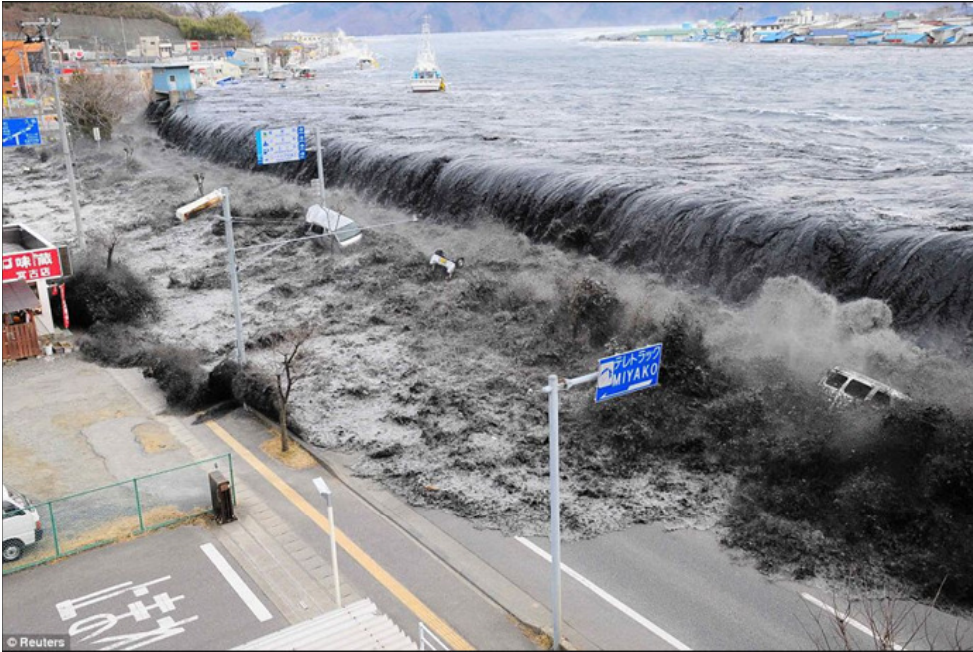
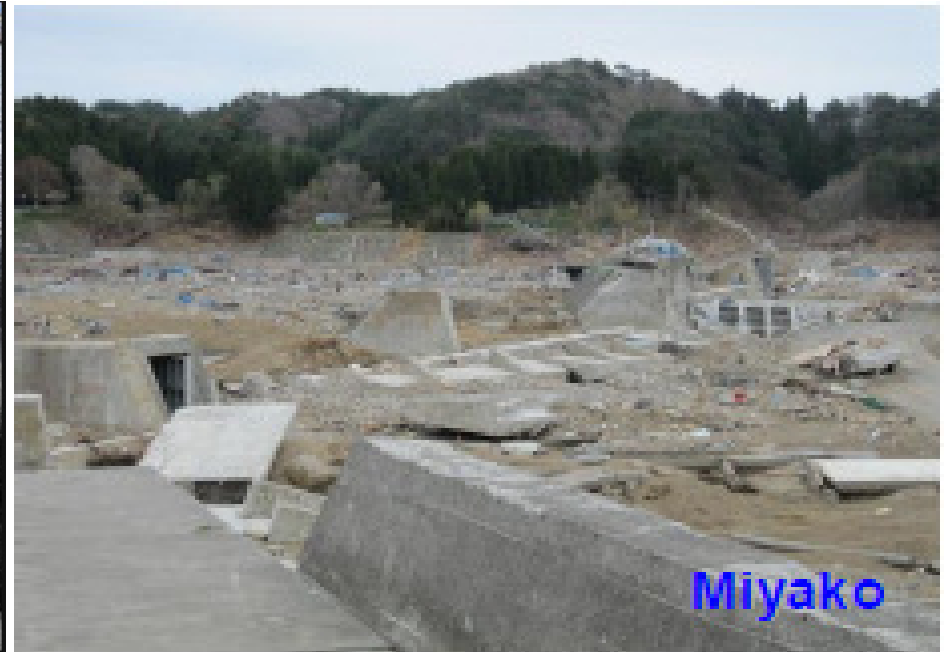
“The tidal embankment in the Taro area of Miyako City in Iwate Prefecture is referred to locally as the “Great Wall of China” as it towers 10 meters high. However, even this collapsed when hit by a tsunami that was 15m high, or possibly higher, and significant damage occurred within the embankment .” From the Japanese Government’s report, June 2011

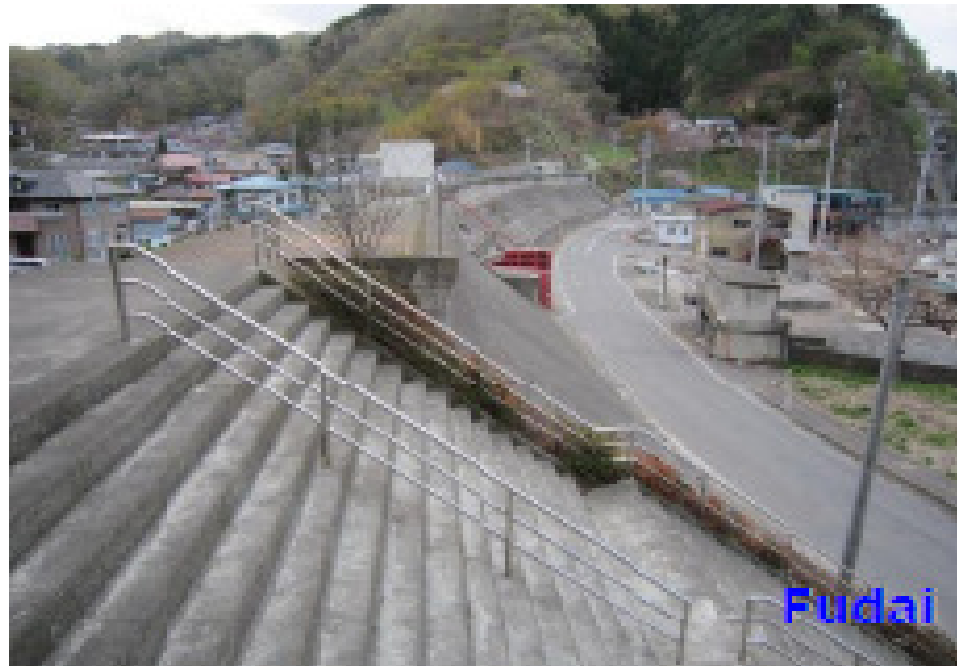
“.....the 15.5 m embankment was installed in the Ootabu area, Fudai village in Iwate Prefecture following a strong desire of the village chief (*sic*) learning from previous experiences with tsunami. This embankment was able to resist the 15m tsunami and prevented the damage within the embankment zone..... These areas are rias type coastlines that have, historically, suffered significantly from giant tsunamis in the 15m range such as the Meiji Sanriku Tsunami (1896) and the Showa Sanriku Tsunami (1933), the lesson of preparation against a 15m-class tsunami has been instructed (*sic*). Against these tsunamis, there was a sharp contrast between the Ootabe area, which heeded the lessons of the past, and the Taro area.” From the Japanese Government’s report, June 2011

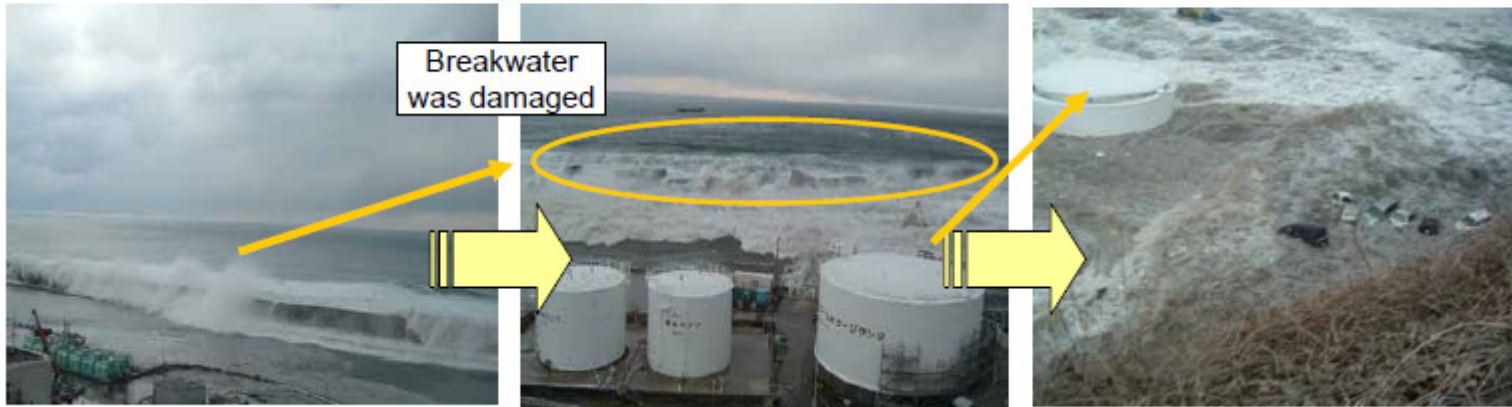
Fukushima Daiichi being struck by the tsunami (1)

Taken from near the south side of Unit 5, looking east

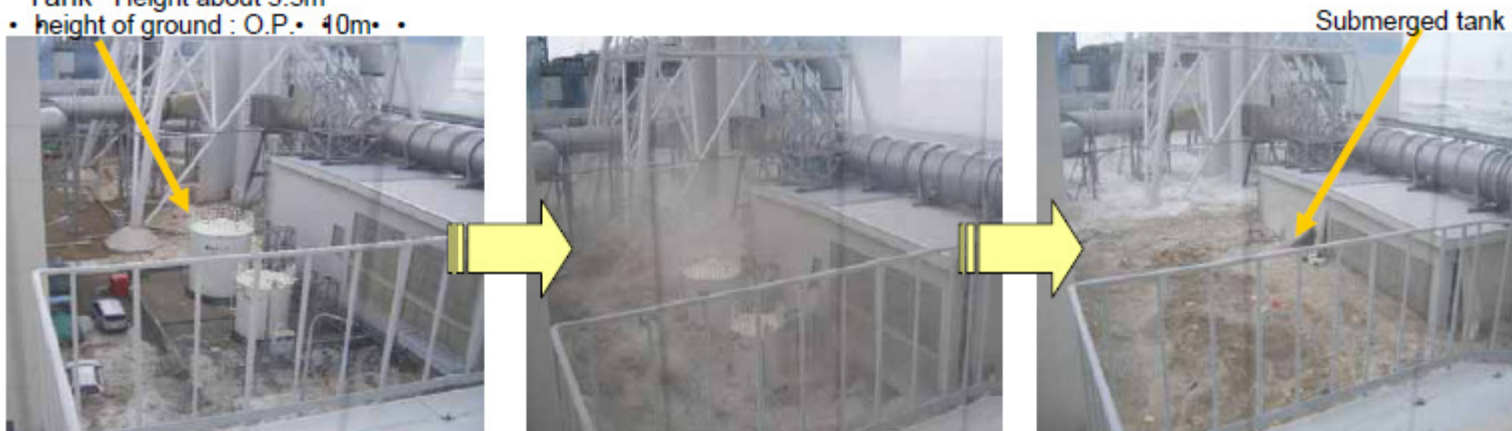
Taken from radwaste building 4th floor, looking north

Tank Height about 5.5m
• height of ground : O.P. • 40m •

O.P. • Onahama bay construction base level

This was the principal mistake. Everything else was a direct consequence.

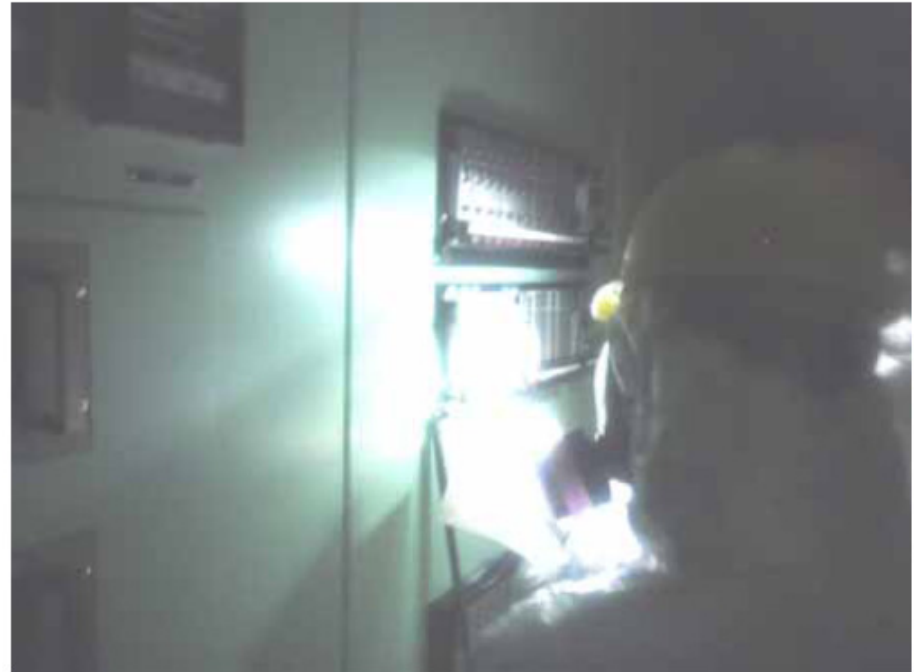
Main Control Room before the lights turned on
Checking a meter gauge with a flashlight in darkness•

- The station was cut off from all grid connections;
- Back-up diesel electricity supplies failed and hence all post-trip cooling was inoperative;
- The roads were impassable;
- Communications were poor;
- Station staff will have been concerned about their families and their homes;
- There were ongoing major aftershocks;
- After the batteries ran out (or failed), the power plants were literally blacked-out. Staff could only find their way round the plant using torches. There were no control room screens or other indications of plant state;
- Station staff will have been keenly aware of the time pressures to try to restore post-trip cooling.

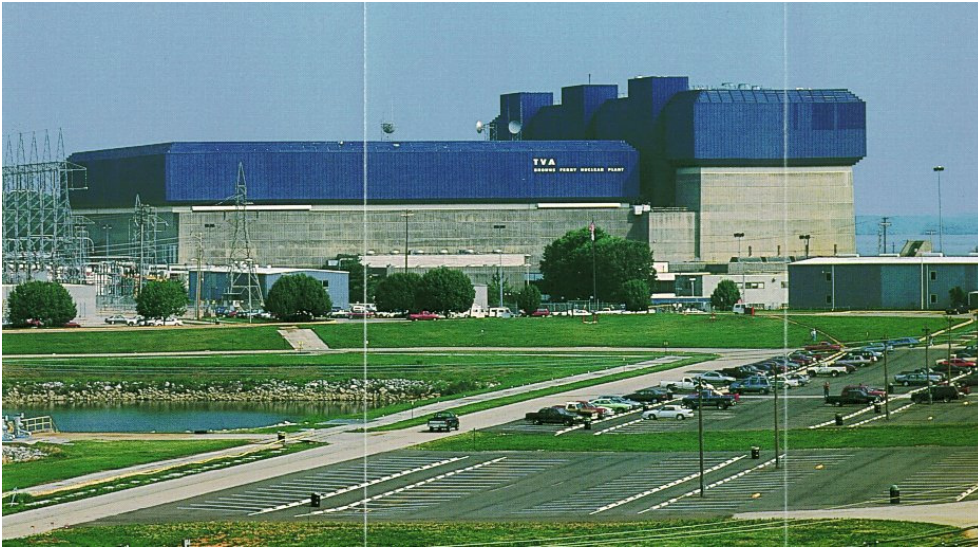
Fukushima Daiichi vs. Browns Ferry

The Tennessee Valley Authority (TVA) owns the Browns Ferry nuclear plant in Alabama, with three BWR units featuring Mark-1 type containments, similar to the Fukushima Daiichi plant design.

- TVA stated that the plants already had explosion-resistant pipes to vent hydrogen from the containment, fire hoses pre-placed to fill spent fuel pools in case of loss of cooling, and hardened diesel rooms, including 7-day supply of fuel, behind water-tight doors. The diesel switchgear is located within the reactor building, and thus is protected from flooding.
- As a result of Fukushima, TVA has bought diesel-driven fire pumps also.

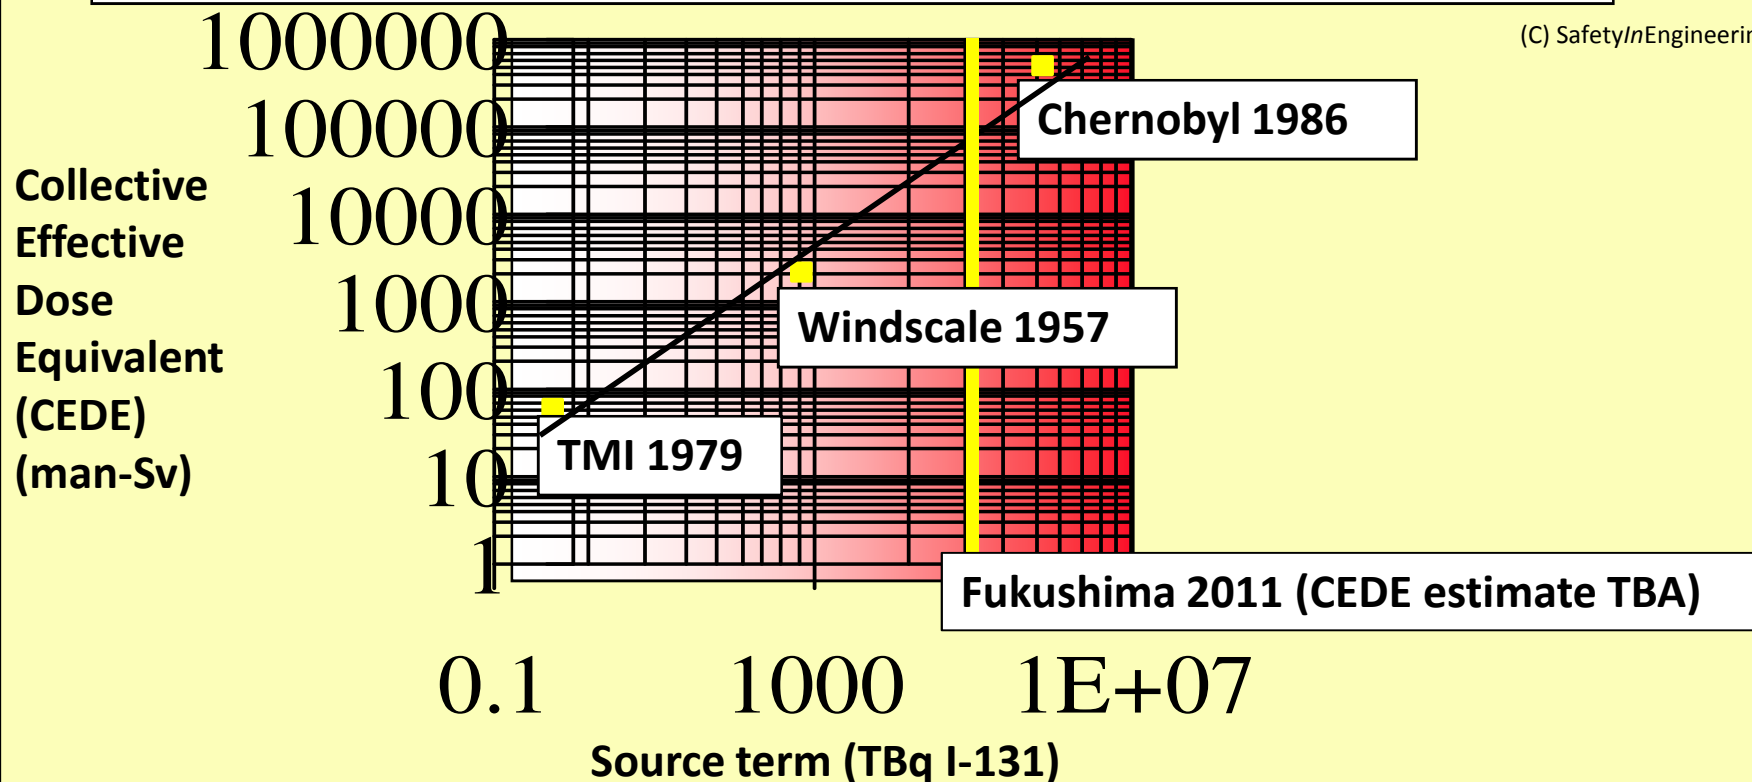
Consequences of reactor accidents – Fukushima update

- The above graph uses I-131 as a surrogate measure of radiological release. Other isotopes (notably Cs and Pu) will also have been significant. I-131 is used for simplicity as a common single measure of the magnitude of radioactive release.

- CEDE estimates are taken from the relevant recognised 'definitive' reports (Kemeny, NRPB, IAEA).
- Using the ICRP risk coefficient of 5E-02/man-Sv leads to deduced cancer mortality estimates from the accidents as follows:

- TMI c.1
 - Windscale c.100
 - Chernobyl c.10000
- Airborne releases after the Fukushima accidents were estimated to be 1.5E+5 TBq I-131 by the Japanese Government in their June 2011 report. CEDE estimates are not yet available. Fukushima also led to significant water-borne releases.

- If the empirical correlation for the first three major accidents (the straight line on the graph) holds true for Fukushima also, then the deduced long-term cancer mortalities for Fukushima are likely to be of the order of 1000.

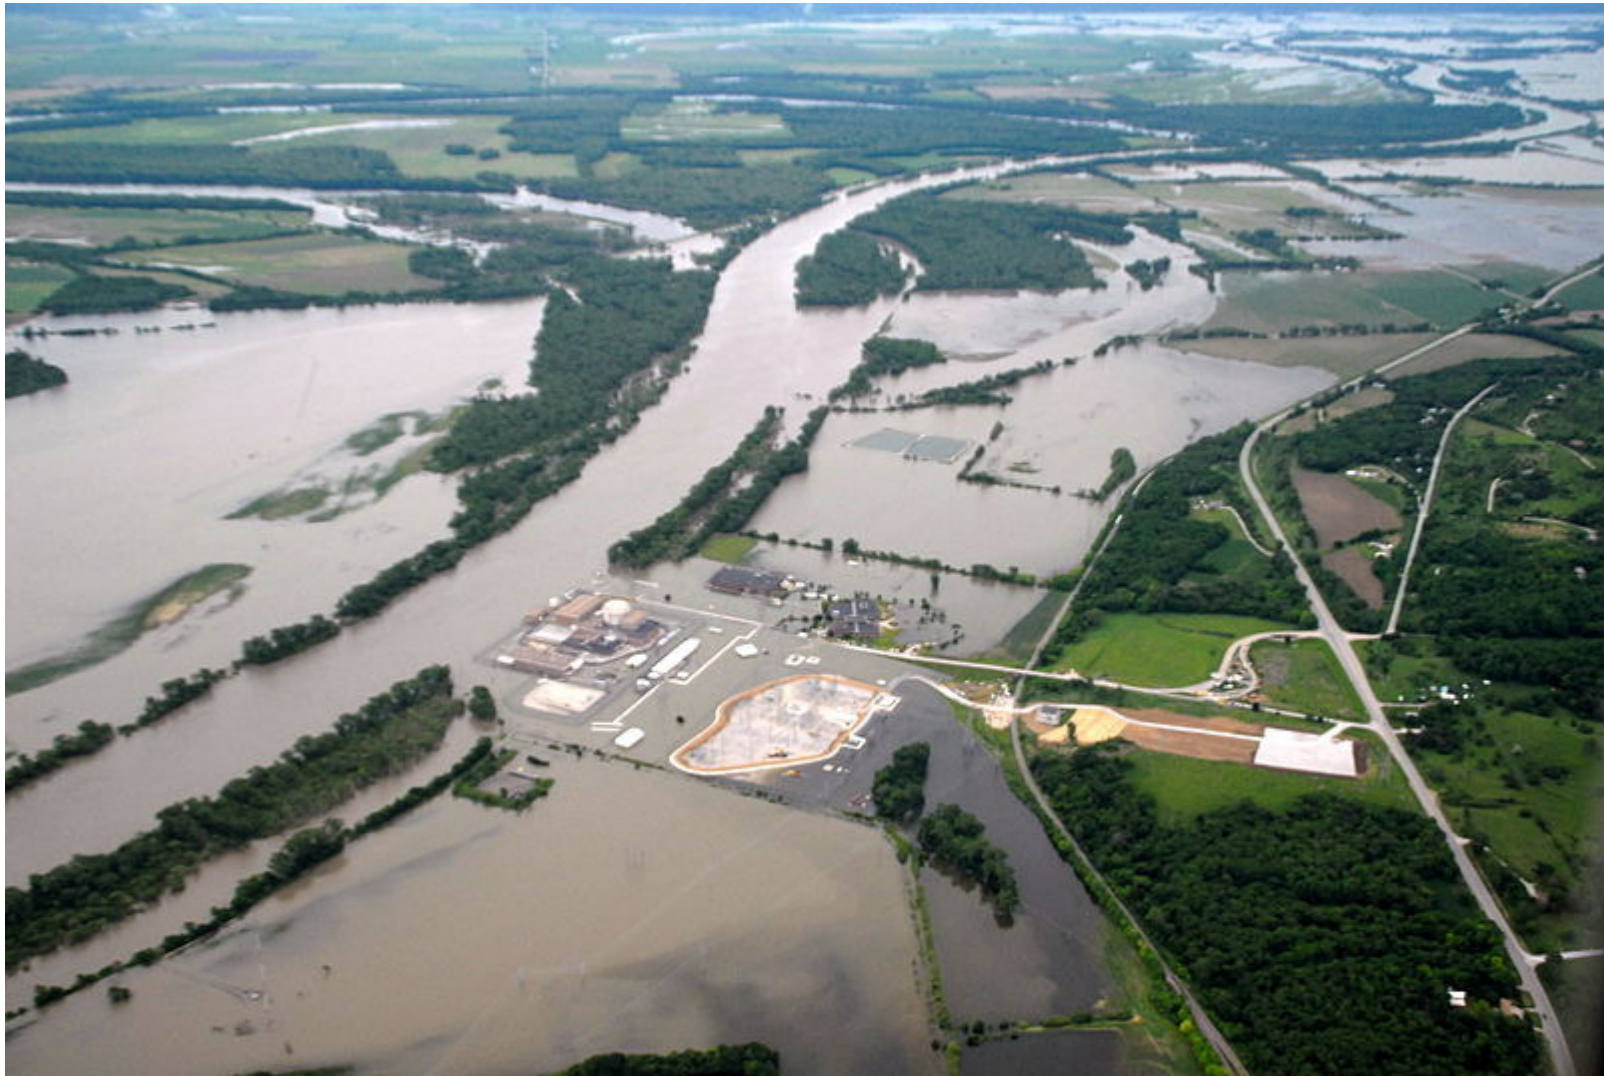
Fort Calhoun, Nebraska, 16th June 2011

(Wikipedia) Flooding began to recede at the end of August.

- Hunterston,
26-27th December 1998 storm
(INES 2)
- Blayais (Gironde estuary),
extra-tropical cyclone,
storm surge/flood,
27th December 1999 (INES 2)
- Fort Calhoun, Nebraska,
Missouri river flood,
spring/summer 2011 (*photo*)

- Obviously none was as severe as Fukushima
- Emergency planning needs to address the likelihood that a nuclear emergency may occur at the same time as a regional emergency
